Radon in Air Testing Report

2018/2019

Red Deer Catholic Regional Schools

Red Deer Catholic Regional Schools 2018/2019

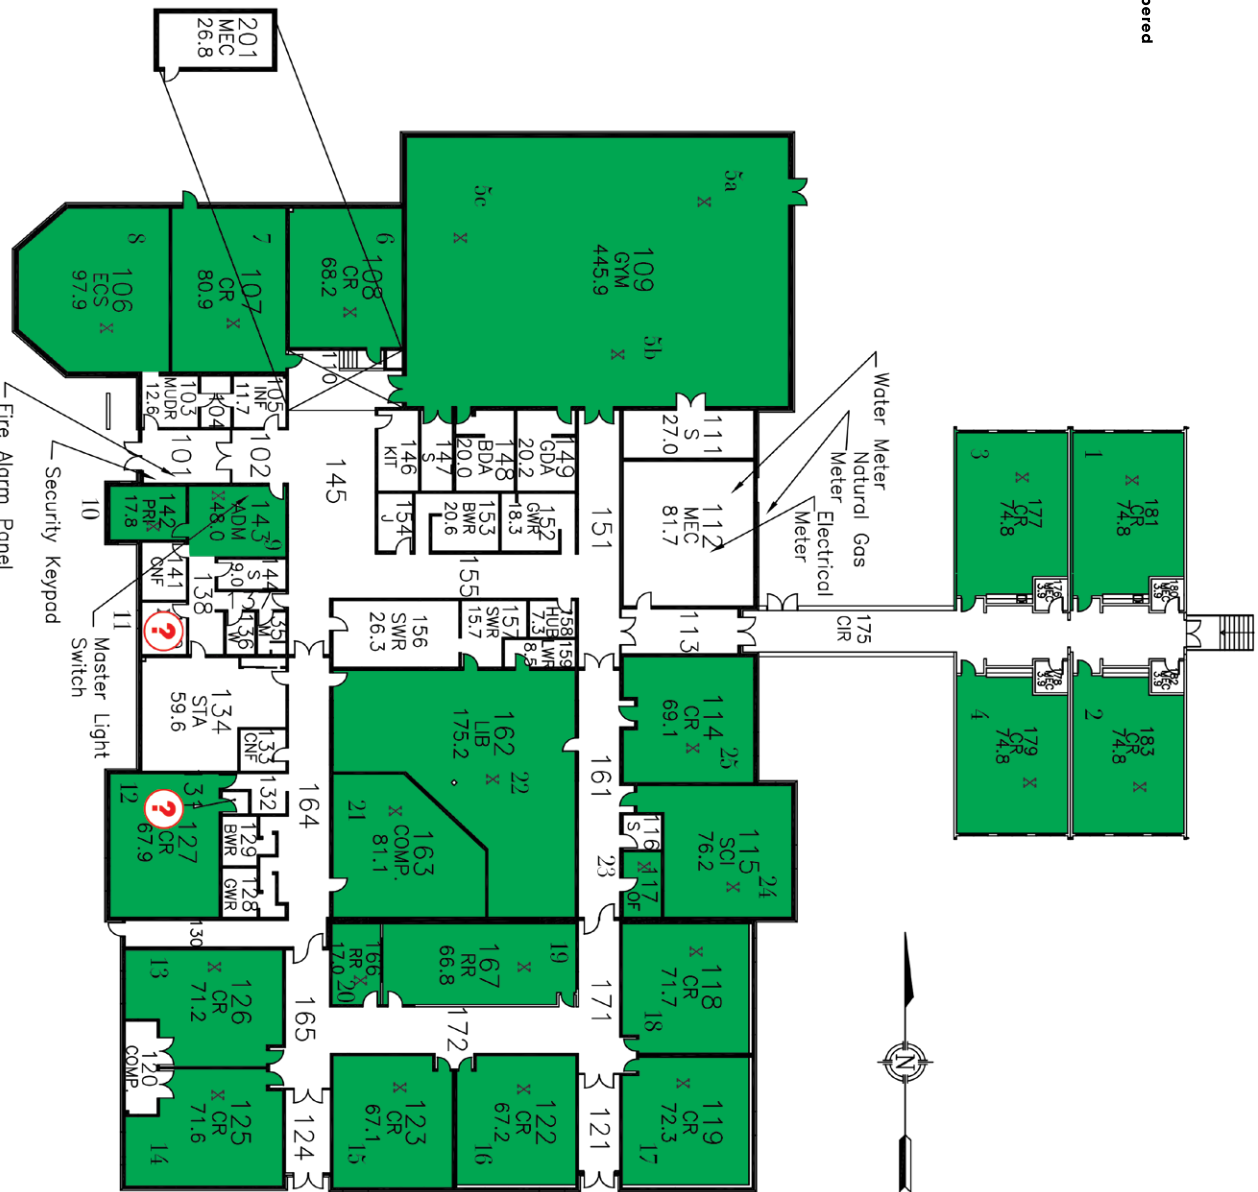
Table 3.11 St. Elizabeth Seton

- Rooms not measured
- <100 Bq/m³
- 100 - 199 Bq/m³
- >200 Bq/m³
- ? Unrecoverable/tampered

Long term radon sampling of selected rooms in St. Elizabeth Seton were well below both Health Canada and World Health Organization action level guidelines.

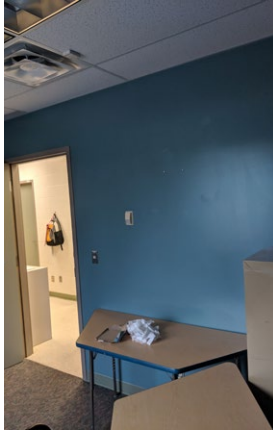
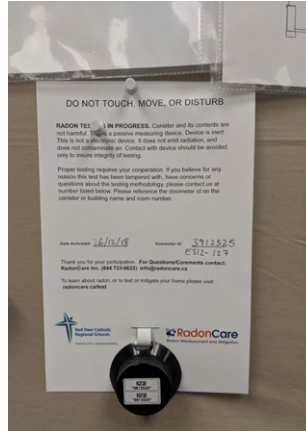
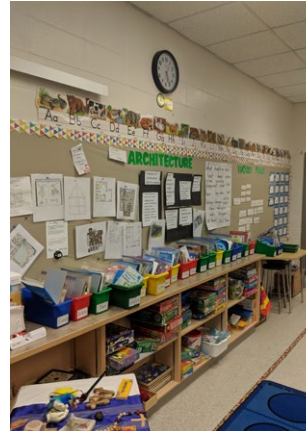
Dosimeter 11-139-3912523 and 11-139-3912524, unrecoverable. Tacks from placard still in place, all contents of room missing. Dosimeter 12-127-3912525 moved to a lower position on wall.

Office where dosimeters 11-139-3912523 and 11-139-3912524 were placed, dosimeter 12-127-3912525.
